ICUR2016
International Conference on Urban Risks

Landslide deformation patterns in peri-urban areas

S.C. Oliveira; J.L. Zêzere; R.A.C. Garcia; S. Pereira

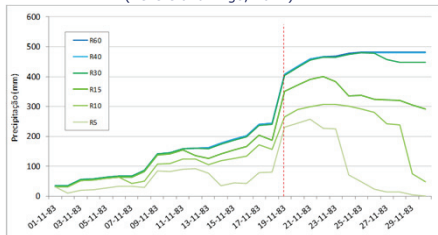
1983 – 164 mm/1 day RP = 194 years
(Zêzere and Trigo, 2011)

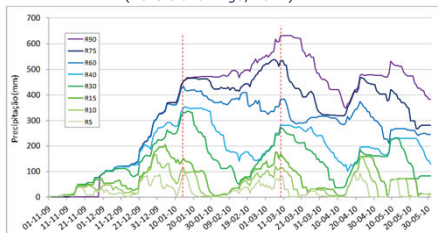
2010 – 632 mm /90 days RP = 8 years
(Zêzere and Trigo, 2011)

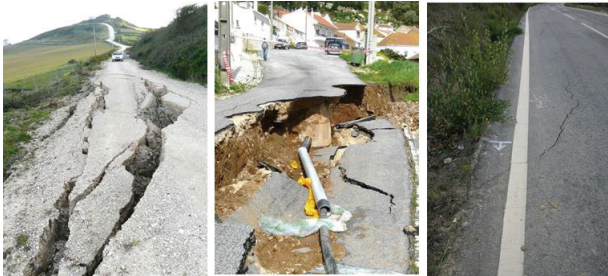
Elements Typology
 ↓
 Structural resistance

ID	Buildings Typology	ID	Roads Typology
E4	Edifícios com elementos resistentes de betão	V4	Highway
E3	Edifícios com paredes de alvenaria argamassada	V3	National road (asphalted)
E2	Edifícios com pedra de adobe ou taipa	V2	Municipal road or similar (asphalted)
E1	Edifícios com outros elementos resistentes (madeira, metal)	V1	Rural road (compacted earth or other less resistant materials)

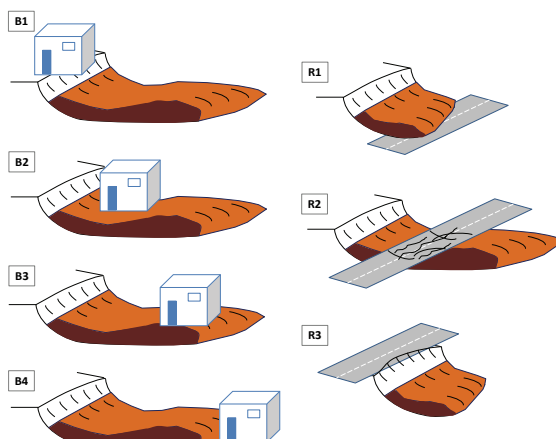
Position of the affected element within the landslide mass

- Buildings and roads location type on different internal sectors of the landslides mass: scarp (B1, R3), depletion area (B2), accumulation area (B3, R1), landslide main body (R2) and landslide front (B4).

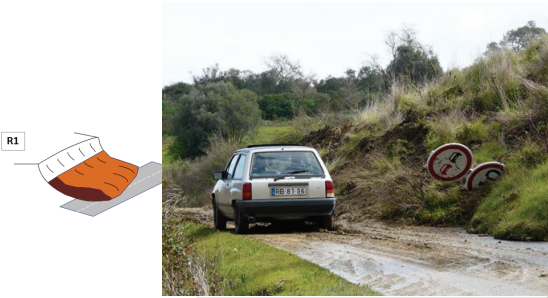
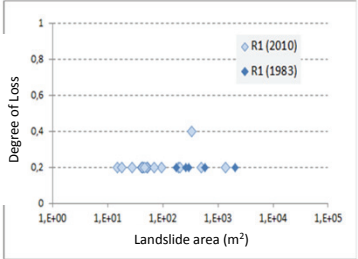
Asphalted roads (V2, V3)

- Independently of the road typology (rural or asphalted) / landslide event – **Damage level D1 (degree of loss of 0.2) is dominant.** Loss of functionality - full or partial interruption (material accumulation does not exceed 0.5 m thickness).
- 3 cases – material accumulation on road up to more than 2 m thickness. Cachoeiras complex slide (roto-translational slide) - road partially or completely interrupted discontinuously between February 2010 to April 2013. No structural damage.

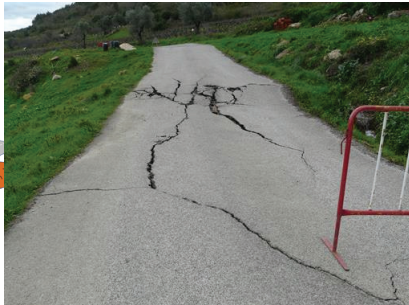
R2

Landslide area (m ²)	Degree of Loss
~1,000	~0.6
~1,500	~0.6
~2,000	~0.6
~3,000	~0.6
~4,000	~0.6
~5,000	~0.6
~6,000	~0.6
~7,000	~0.6
~8,000	~0.6
~9,000	~0.6
~10,000	~0.6

Rural roads - Damage 0.4 to 0.6. Fractures and pavement deformation, horizontal/vertical displacement, could allow vehicles circulation or road traffic restoration in short time. Landslides > 100 m²

Asphalted roads – Damage 0.6 (3 cases). Deformation and fractures affecting the road structure, restoration of vehicles circulation, even on a temporary road pavement , after seven days.

Landslides - 1000 and 10,000 m².

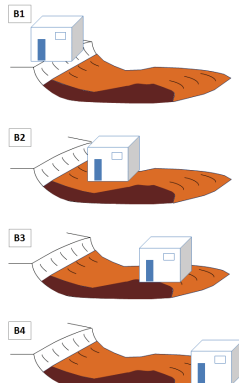
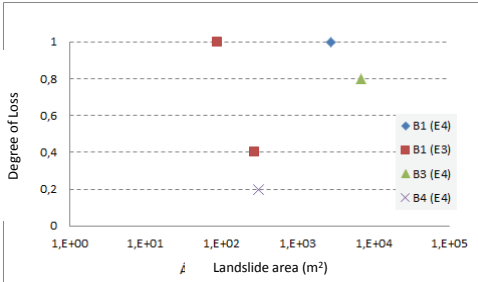
Reduced number of cases (5) - Is not possible to accurately determine a deformation pattern. 4 cases (2010 event). 1 case (1983 event) (B1 (E3) degree of loss = 0.4).

Considering the relationship B1 and B3, and the types of buildings E3 and E4, the **higher degree of damage (above 0.8)** was only registered on slides with an area greater than 2500 m².
